Prepared For: Sample Report.
(Name of Client)

Concerning: 907 Somewhere Drive. Dallas TX 76000.
(Address or Other Identification of Inspected Property)

By: James A. Dickey. TREC # 5718. 7/31/08.
(Name and License Number of Inspector) (Date)

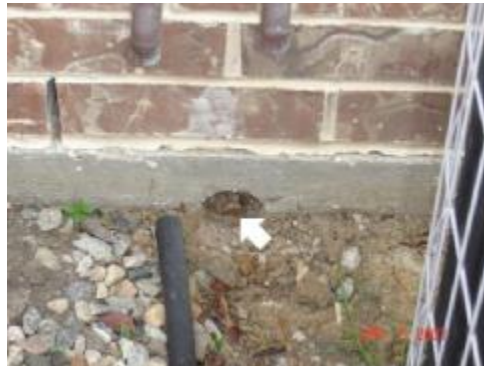
**Post tension cable ends exposed and should be protected from the elements.
 Recommend treat rust with a rust inhibitor and seal cable ends.**

Post tension cable ends are exposed.

Post tension cable ends exposed and should be protected from the elements. Recommend treat rust with a rust inhibitor and seal cable ends.

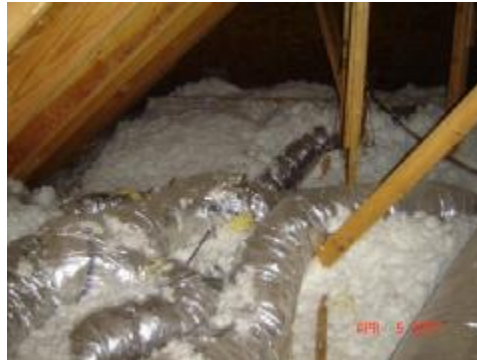
Ducts are not suspended off the attic floor as required. Recommend suspend all ducts off the attic floor.

Ducts are on attic floor.

Ducts are not suspended off the attic floor as required. Recommend suspend all ducts off the attic floor.

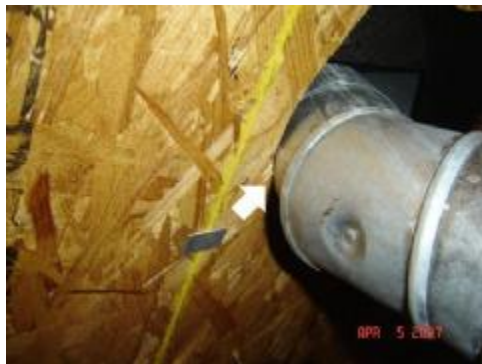
Water heater flue vent is in contact with combustibile material in the attic. Recommend trim decking away from flue vent as required.

Flue vent is in contact with decking.

Water heater flue vent is in contact with combustible material in the attic. Recommend trim decking away from flue vent as required.
